# Refrigerator OQC Report Generation

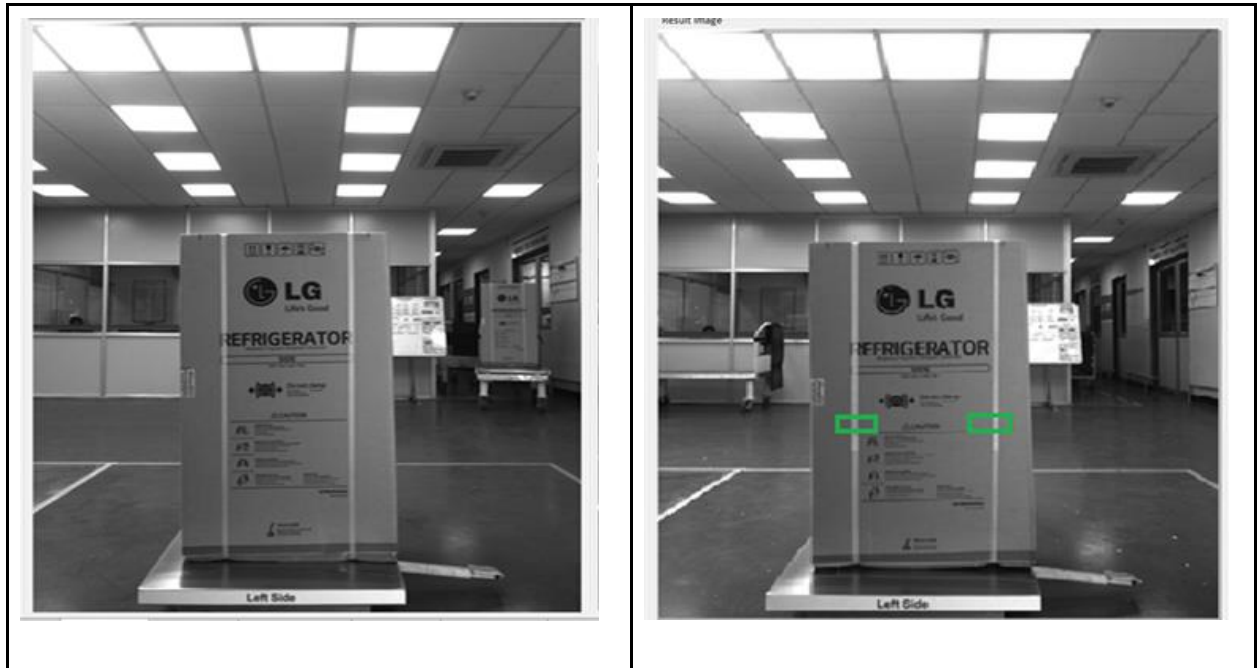
## Images

<i>Captured Image</i>	<i>Annotated Image</i>
-----------------------	------------------------

Machine vision technology helps us to inspect the puff leak in the refrigerator. We have used 'AI' software which is rule-based image processing software developed by Teledyne dalsa. Here, we used two 1.3 MP cameras. Industrial PC's with POE cards and DIOs were deployed to reduce the image processing time.
