Steel Strip Defect Identification

Problem Faced

Technology introduced by Qualitas Technologies

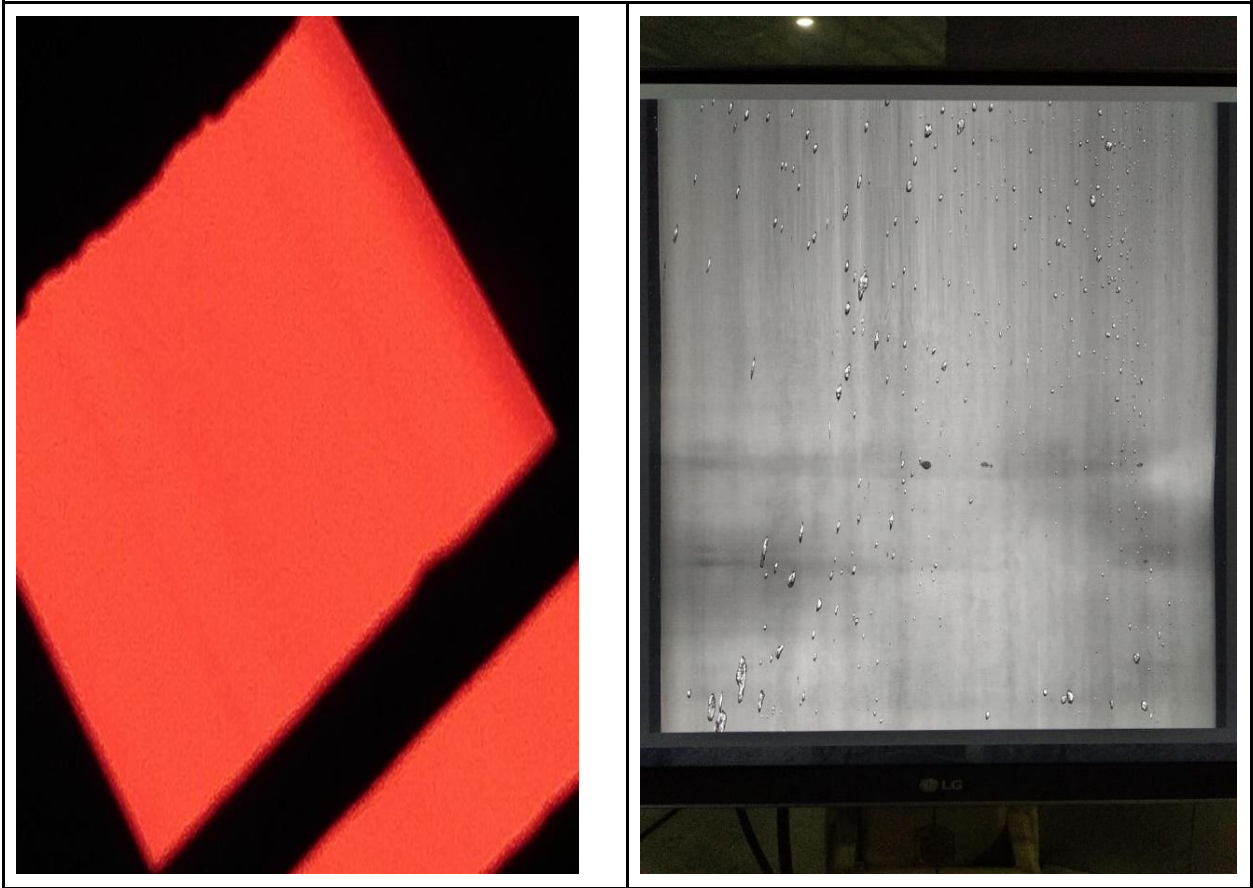
Images

<i>Original Image</i>	<i>Camera Image</i>
-----------------------	---------------------

NOTE:- The original image is the standard image of the hot metal sheet as captured by a standard camera, the Camera Image denotes the image taken by the setup installed by Qualitas. As we can see, the defects are clearly visible.

- A high-resolution image is captured by 8K line scan camera in binning mode, Result image will have 2MM pixel accuracy with 20 Microns pixel size
- Image Size: 16Mb. 4096 x 4096 Pixels. FOV: 2000 x 2000
- Though strip is red hot & emits radiation, High-intensity line light flare will enable us to overcome the radiation & strip looks as it is in room temperature
- IPC with a frame grabber & 10GBPS network card will acquire 7.5 Gb data per minute & transmit the same to the server through a 10GBPS network card.
