# USE CASE

## SURFACE INSPECTION OF ENGINE'S CYLINDER HEADS

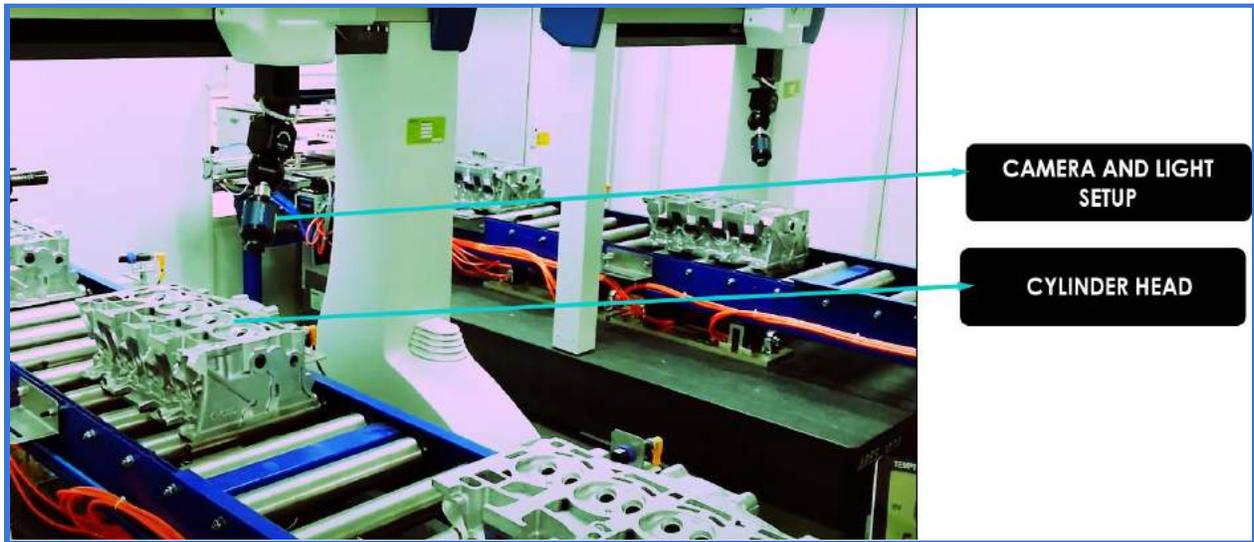
## SETUP

A camera or set of cameras with appropriate illumination (red lights in this case) is set up to [identify the defects](#) on the cylinder head surface. Images are captured and sent to the software ([Qualitas EagleEye® Platform](#)) cloud where the training is done using the deep learning algorithm. Once the program is trained, real-time defect detection takes place, based on which the results are sent to PLC to take action.

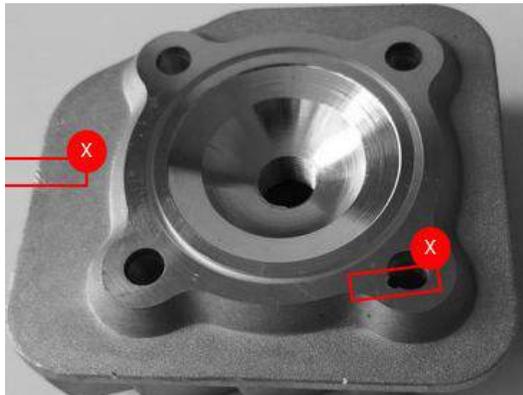
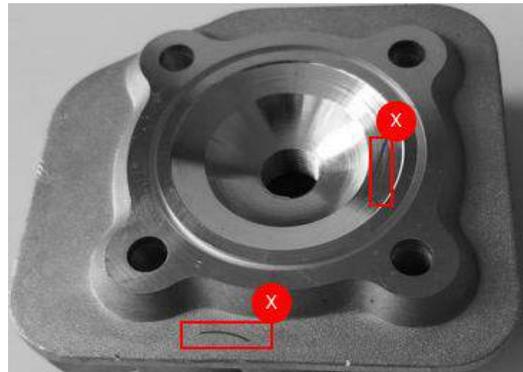
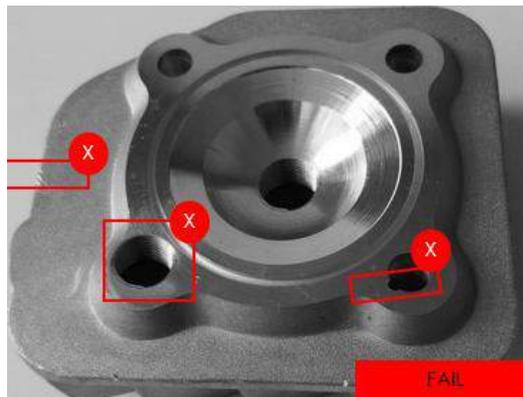
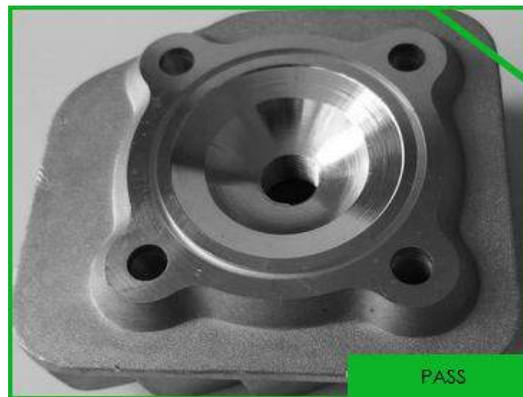
## IMAGES

DETECTING DEFECTS IN QEP(QUALITAS EAGLE-EYE® PLATFORM)

1. The false acceptance rate is reduced to ~ 1-2%
2. The accuracy of defect identification is ~ 98%
3. Early detection is possible with the vision system and also the root cause can be found
4. The machine vision system has the potential to reduce/eliminate the cost of skilled labor
