# USE CASE

## SURFACE INSPECTION OF GRINDING DISCS

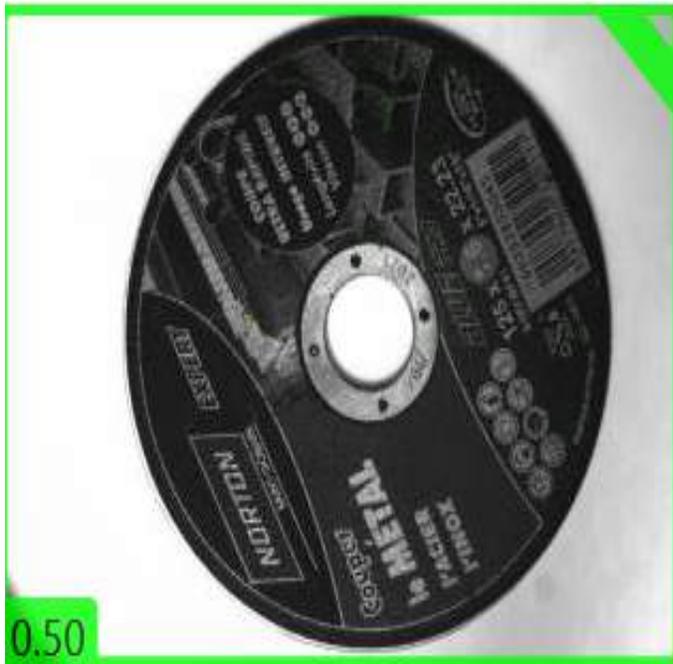
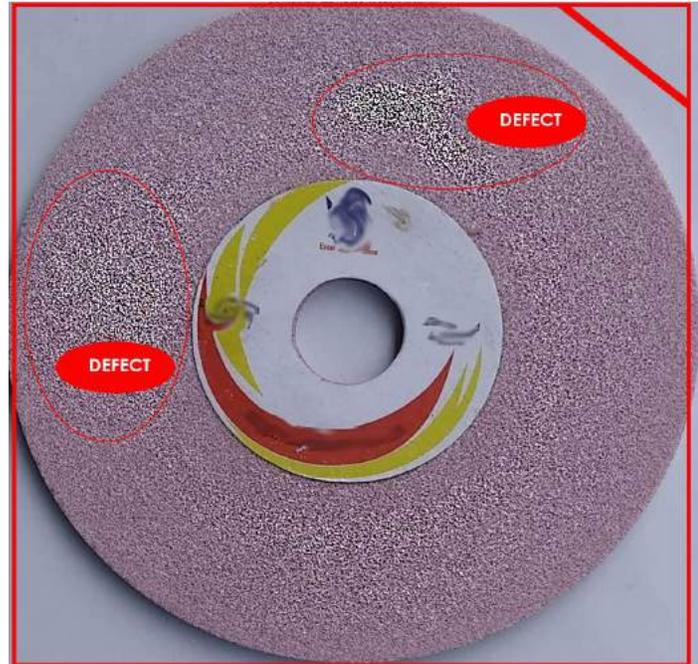
The disc from the stack will be lifted through the vacuum suction, once it is lifted the bottom part of the disc is imaged to identify the surface anomalies after which the disc will be placed on the conveyor, once it is placed on the conveyor the top part of the disc is imaged using another camera to identify the surface anomalies.

A camera or set of cameras with appropriate illumination is set up to [identify the defects](#) on the grinding wheels. Images are captured and sent to the software ([Qualitas EagleEye® Platform](#)) cloud where the training is done using deep learning algorithms. Once the program is trained, real-time defect detection takes place, based on which the results are sent to PLC to take action.
