# CASE STUDY

## INSPECTING LABEL USING OCR TO REMOVE MANUAL DATA ENTRY OF CIGARETTE PACKET DETAILS

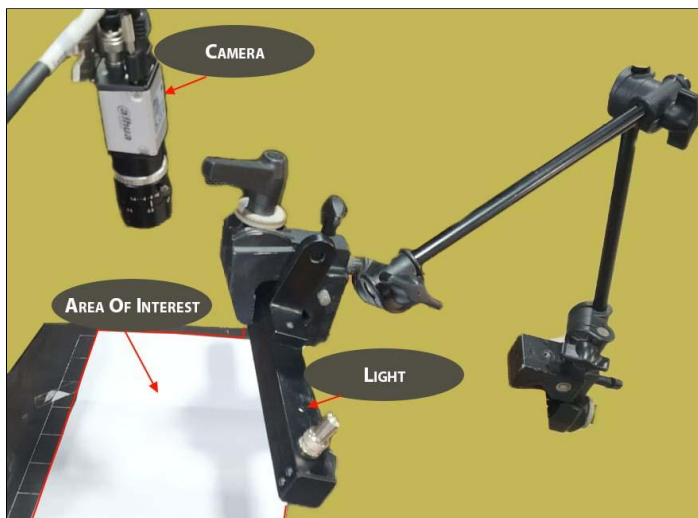
A machine vision system was set up at the inspection station. A 4I (Install, Instruct, Inspect and Improve) methodology is used with the above configuration for the deployment of the machine vision system. The 4I method is discussed as follows -

An EagleEye camera facing towards the area of interest was fixed along with the lights. White bar lights were used to illuminate the area of interest. Light and camera setup were enclosed in a fiber frame in order to prevent the reflection of the lights on the cigarette packs. A 16mm lens was used in the image acquisition of the printed characters for

FOV (Field Of View) of 100 mm x 100 mm. The distance between the camera and the object (to be inspected) i.e. working distance is 130 mm.

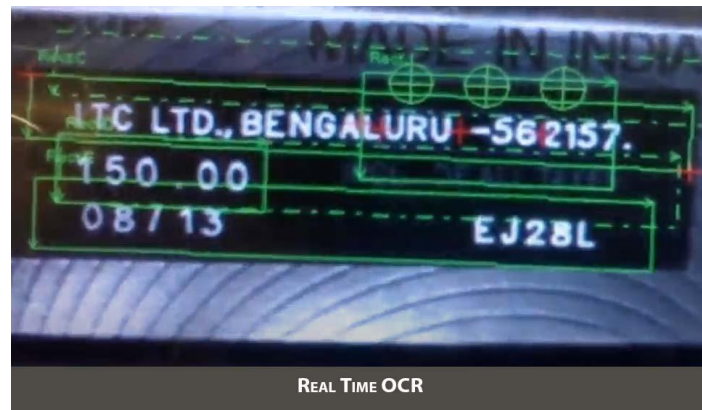
## IMAGES

REAL-TIME LABEL INSPECTION USING QEP(QUALITAS EAGLE-EYE® PLATFORM)

1. The accuracy of the read rate was more than 94 percent. As a result, the correct data could be entered into the ERP systems.
2. The inspection cycle time for OCR is reduced to 350 milliseconds, which saves 95 percent of the time (taken in manual inspection).
3. Human operators were completely replaced with the deployed system helping in reducing the cost of labor and training.
