Item Classification

Technology introduced by Qualitas Technologies

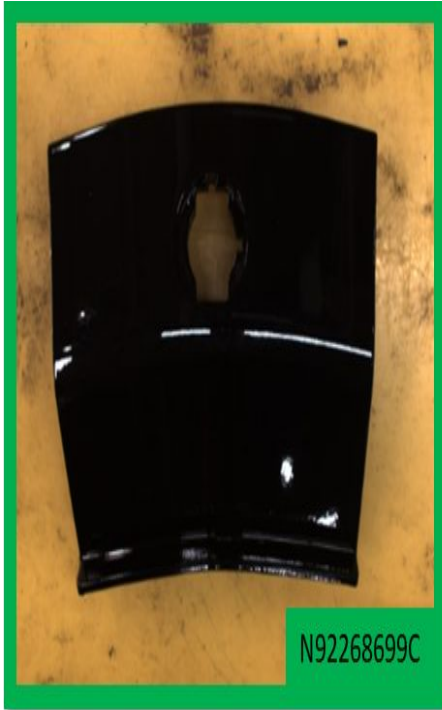
<p data-bbox="500 1577 626 1619">N92268699C</p>

<i>Captured Image</i>	<i>Annotated Image</i>

The set-up required would be a typical machine vision setup where the camera was mounted on the top of the inspection table to image the top surface of the component. FOV was adjusted to cover the component having maximum dimensions. Background had to be kept uniform and clear to avoid confusion. The acquired training image set was then labelled/tagged with the correct.
