# Label Classification

## Problem Faced

## Solution

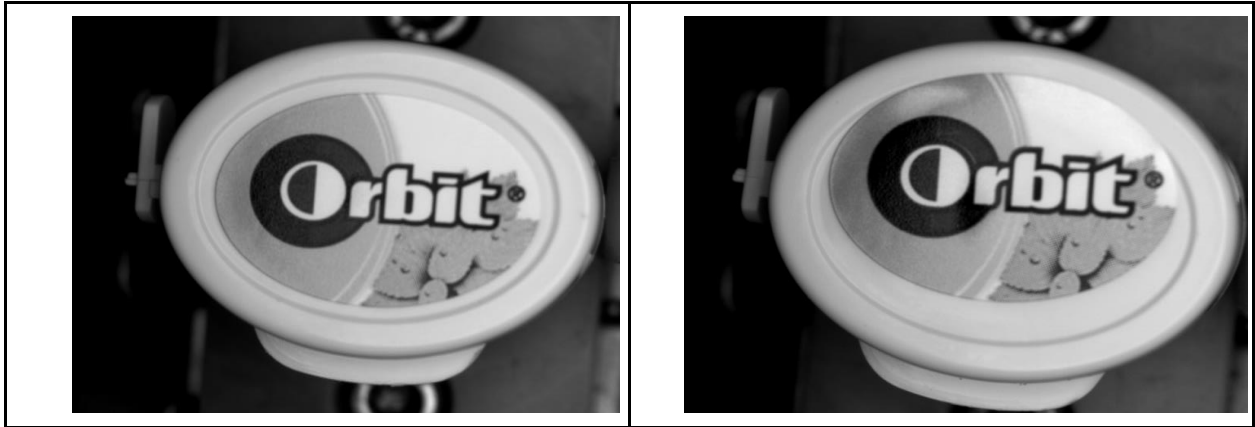
<i>Captured Image</i>	<i>Captured Image</i>
-----------------------	-----------------------

- The labeled caps are moving on a Conveyor of a labeling machine.
- A high-resolution area scan camera fitted with a lens will be mounted at the top to capture the alignment of the label.
- The presence of the cap is sensed by the sensor and the trigger is generated for the image acquisition.
- Acquired images are processed in GPU based PC by using Deep learning models for defect detection (pre-trained).
- Captured images are displayed on custom-built UI. Also, the signal is given to PLC whenever the defect is detected so that the rejection mechanism will push the defective cap into a separate bin.
