USE CASE

PRINT DEFECT IDENTIFICATION USING VISION INSPECTION

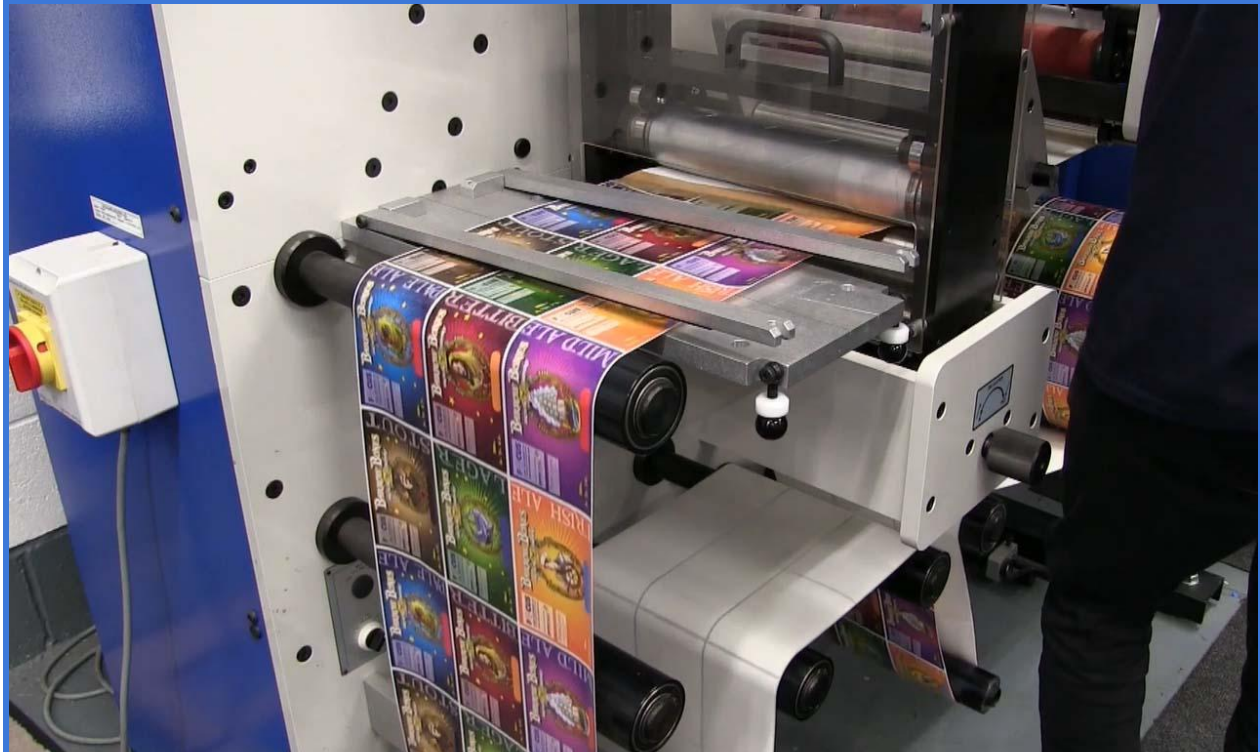
A camera with a specialized lens and appropriate illumination (collimated line light) is set up to identify the defects on the labels. Images are captured and sent to the software (Qualitas EagleEye® Platform) cloud where the training is done using the Deep Learning algorithm. Once the program is trained, real-time defect detection takes place. Based on which the results are communicated to PLC to take action(stop the line to remove the defective labels).

Here the **OCR and Anomaly Detection tools** are used to identify the defective labels on the rewinding machine.

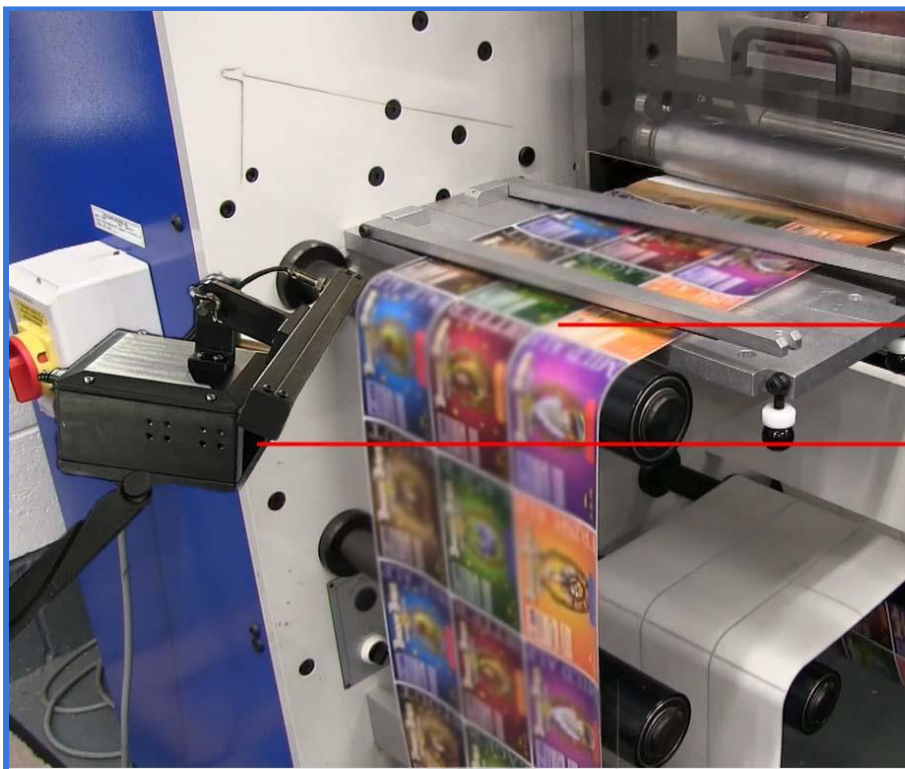
WINDING MACHINE SETUP

**STICKERS TO
INSPECT**

**VISION SETUP
CAMERA AND LIGHTS**

VISION SYSTEM AND WINDING MACHINE (SETUP)
