CASE STUDY

SKU COUNT IN THE PALLETS USING AI-BASED MACHINE VISION SYSTEM TO ELIMINATE COUNTING ERRORS

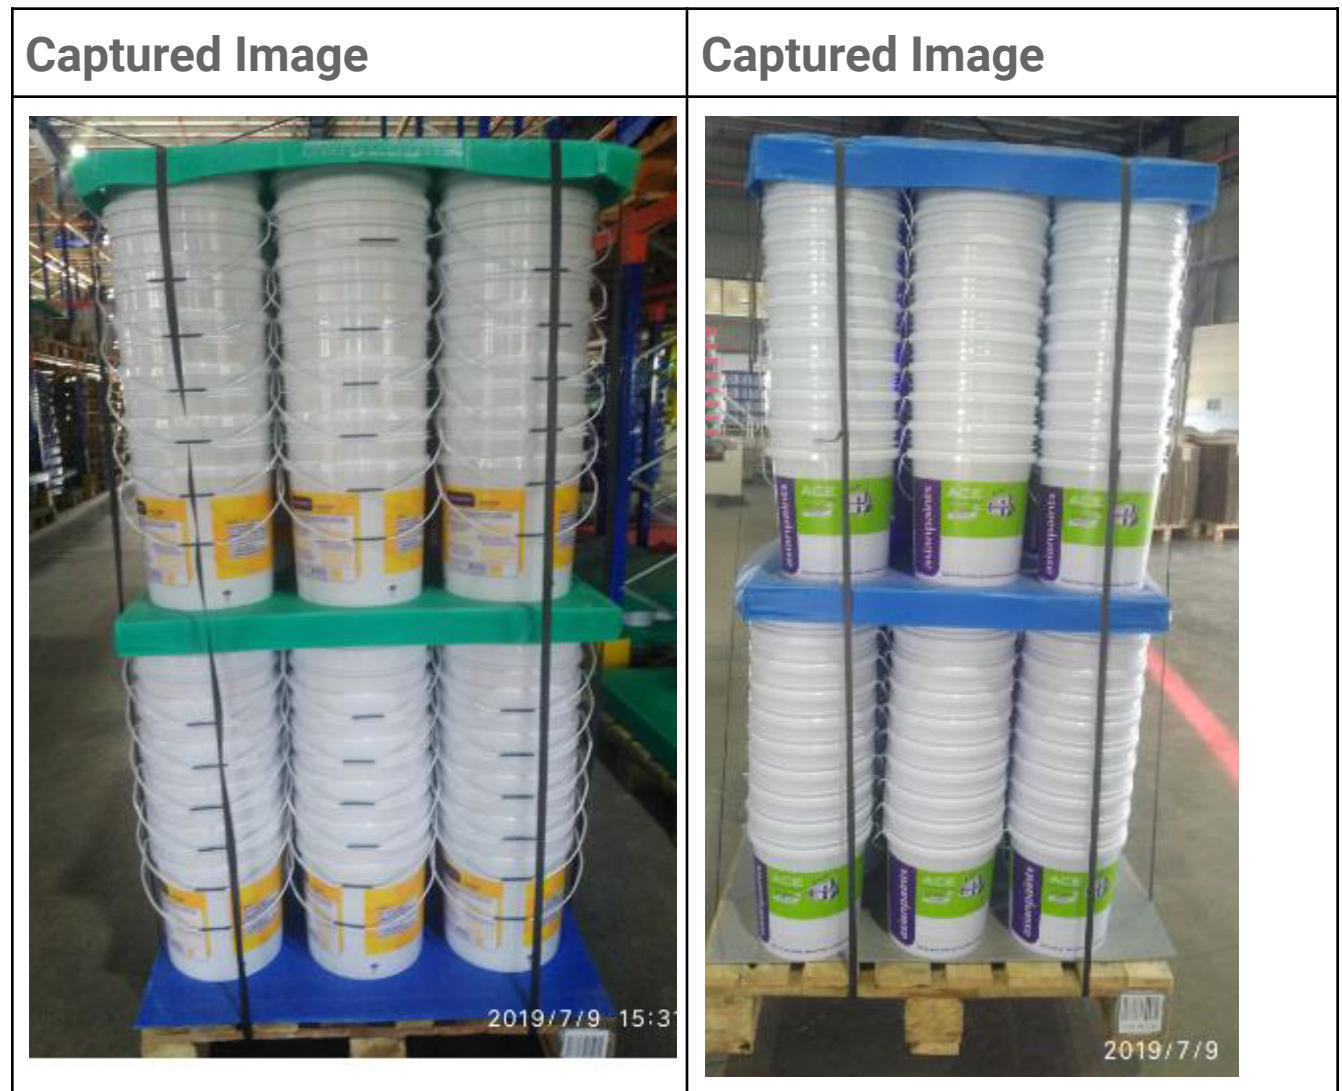
IMAGES

Four machine vision cameras are used for successfully capturing images of each of the 4 sides of the cartons. Each of the 4 images would be processed using a Deep Learning based processing module which would identify the number of tubs/pails present in each layer. The results of all 4 images would be interpolated to arrive at the total count.

- **Object detection techniques are used to** count the total number of SKUs in a pallet and identify the layer separator.
- **Classification techniques are used to** look for mismatches of pallet contents.
