CASE STUDY

AUTOMATED SURFACE INSPECTION OF LPG CYLINDERS TO IDENTIFY DENTS USING 2D CAMERA AND LASER GRIDS (AI VISION SYSTEM)

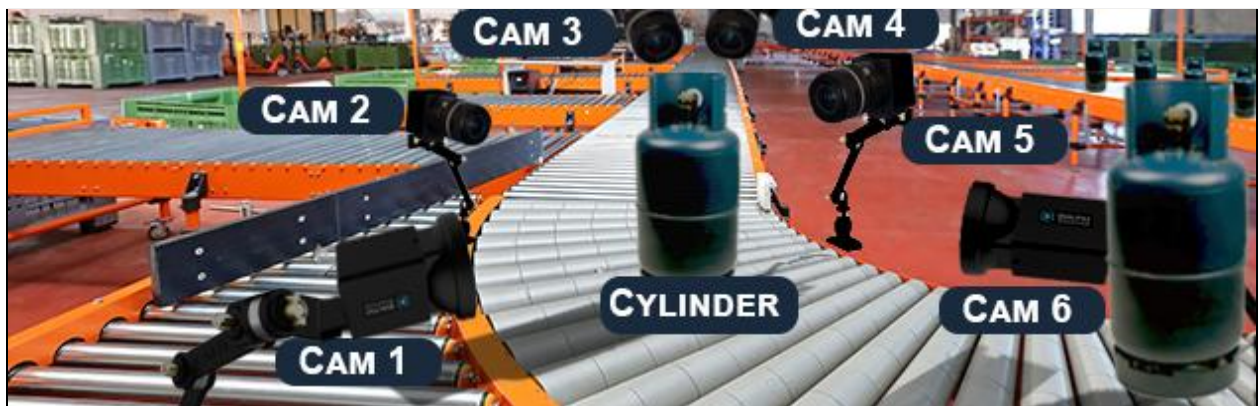
A setup of 6 cameras (to capture 360 degrees) and appropriate lighting were set up to best capture the surface defects of the cylinders.

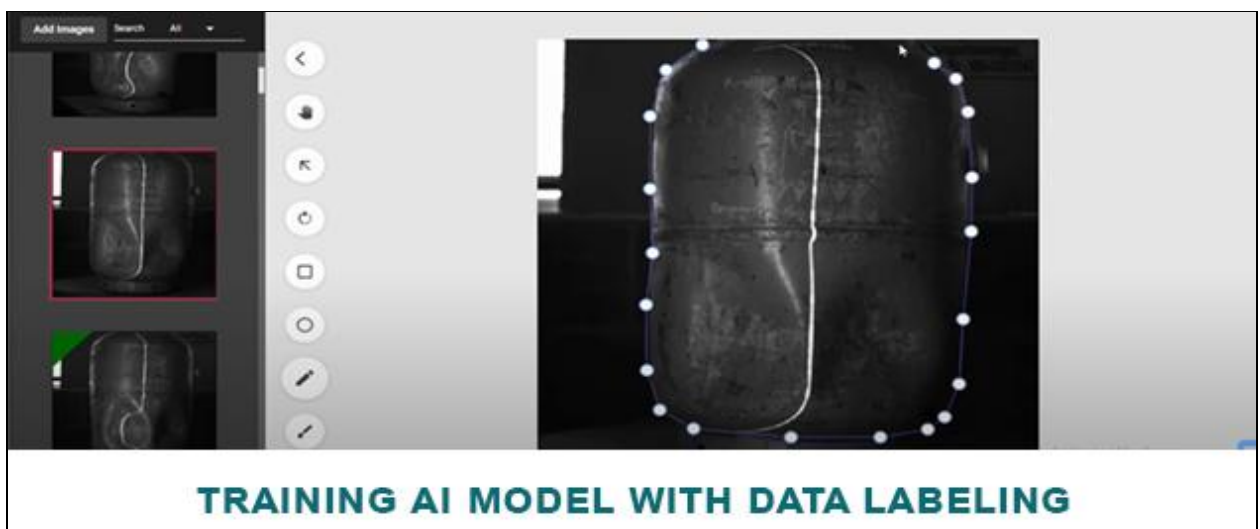
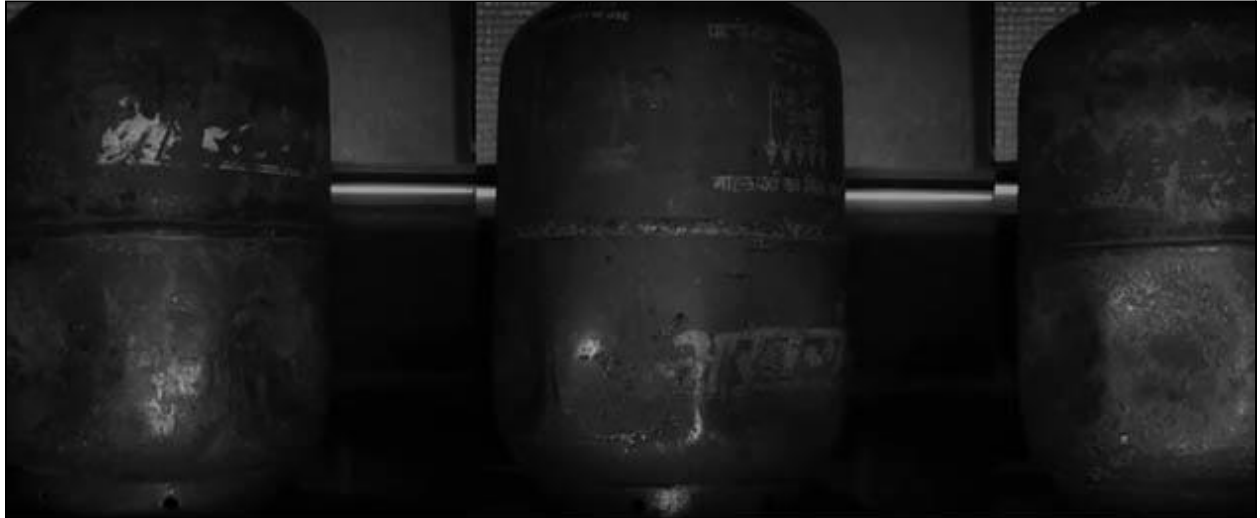
IMAGE ACQUISITION OF DENTED CYLINDERS

A solution is developed using the acquired images of all types of defects. Each type of defect is trained, with the help of a different set of images.

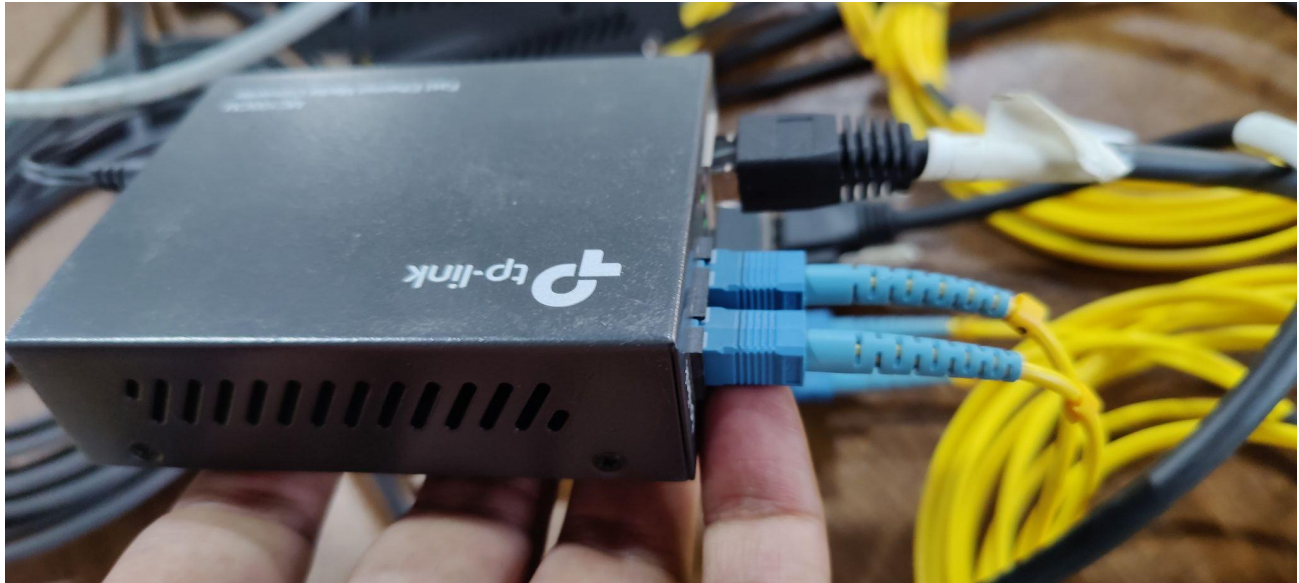
Six 'Media Converters' were used to increase the speed of data transfer of all 6 cameras through the GigE interface. The latency was reduced and image acquisition with image transfer took place in real-time.

The distance between the camera and computing device was longer than 600 meters. This caused latency in image acquisition. Because of the long GigE cable, data transfer took a delay of 1-2 seconds.
