CASE STUDY

# INSPECTING LABEL USING OCR TO REMOVE MANUAL DATA ENTRY OF CIGARETTE PACKET

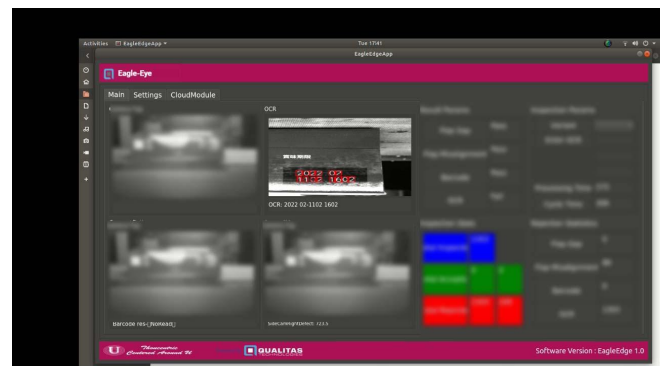
Once the AI model is trained the image acquisition, processing and inferencing occur in real-time (in **EagleEye Edge App**). Though the system is trained, it is still learning, and therefore the character fonts which are not trained may not get identified and UI shows the result as 'Fail'.
